Smoke and Dye Testing Summary

High Level Sewershed

Test ID	Test Type	Date Inspected	Company / Super.	Blower MH	Ground Condition	Notification Made?	Total Length
S1028-180	Smoke	7/21/2009	ADS/TM	S15AA_019MH	Dry	Yes	929.76

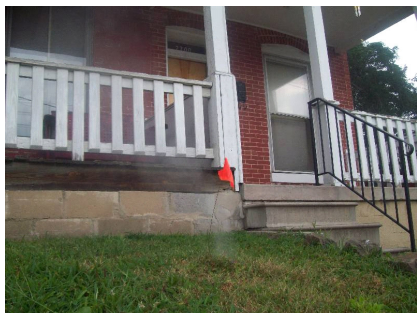
Picture \S1028-180-OB01-P01.jpg

Obs_ID S1028-180-OB01
Address 2702 Lafayette Ave
Status Private
Source Cleanout

Comments Smoke from cleanout (missing cap) in front yard. 2702 Lafayette Ave.

Comments Front of house, 2702 Lafayette Ave.

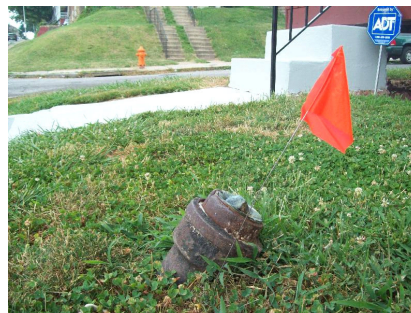
Picture \S1028-180-OB02-P01.jpg

Obs_ID S1028-180-OB02
Address 2704 Lafayette Ave
Status Private
Source Cleanout

Comments Smoke from above-grade cleanout (broken cap) in front yard. 2704 Lafayette Ave.

Comments Front yard, 2704 Lafayette Ave.

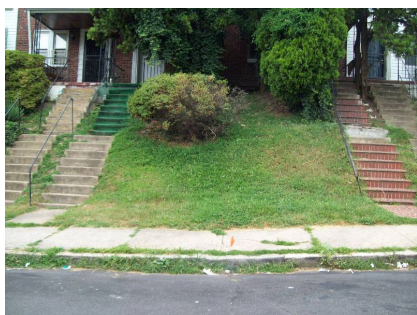
Picture \S1028-180-OB03-P01.jpg

Obs_ID S1028-180-OB03

Comments Smoke from pipe outlet in curb at 910 Ashburton St. Possible connection to downspout.

Comments Front of house, 910 Ashburton St.

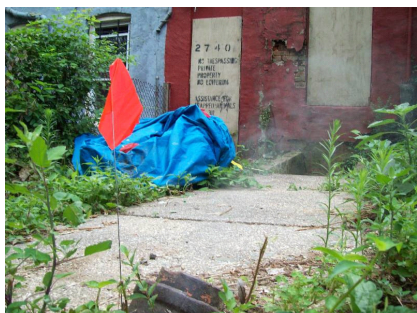
Picture \S1028-180-OB04-P01.jpg

Obs_ID S1028-180-OB04

Comments Smoke from above-grade cleanout (missing cap) in back yard. 2740 Lafayette Ave.

Comments Back of house, 2740 Lafayette Ave.

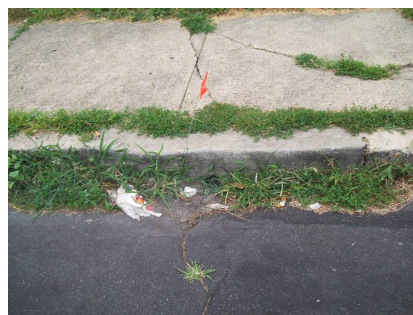
Picture \S1028-180-OB03-P02.jpg

Obs_ID S1028-180-OB03

Comments Smoke from pipe outlet in curb at 910 Ashburton St. Possible connection to downspout.

Comments Sidewalk, 910 Ashburton St.

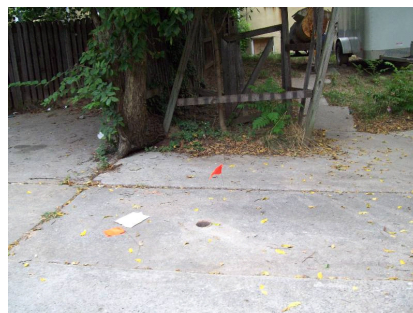
Picture \S1028-180-OB05-P01.jpg

Obs_ID S1028-180-OB05

Comments Smoke from cleanout (missing cap) in alley behind 2741 Prospect St.

Comments Back of house, 2741 Prospect St.

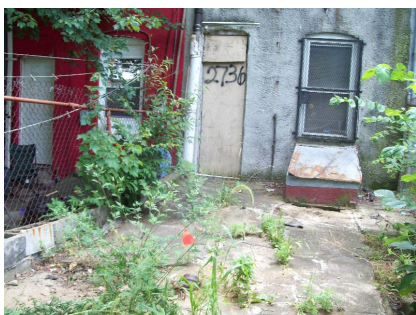
Picture \S1028-180-OB06-P01.jpg

Obs_ID S1028-180-OB06

Comments Smoke from above-grade cleanout (missing cap) in back yard. 2736 Lafayette Ave.

Comments Back of house (location view), 2736 Lafayette Ave.

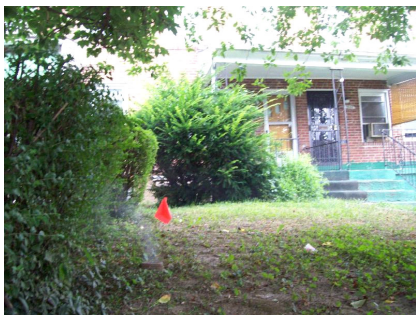
Picture \S1028-180-OB07-P01.jpg

Obs_ID S1028-180-OB07

Comments Smoke from above-grade cleanout (missing cap) in front yard. 2644 Lafayette Ave.

Comments Front of house, 2644 Lafayette Ave.

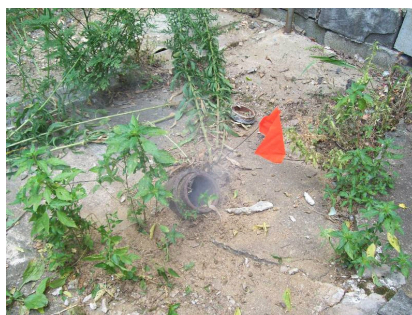
Picture \S1028-180-OB06-P02.jpg

Obs_ID S1028-180-OB06

Comments Smoke from above-grade cleanout (missing cap) in back yard. 2736 Lafayette Ave.

Comments Back of house, 2736 Lafayette Ave.

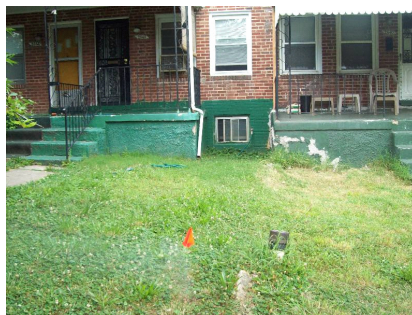
Picture \S1028-180-OB08-P01.jpg

Obs_ID S1028-180-OB08

Comments Smoke from below-grade cleanout (missing cap) in front yard. 2642 Lafayette Ave.

Comments Front of house, 2642 Lafayette Ave.
